AERONAUTICAL CHARTING FORUM Instrument procedures Group April 29-30, 2002 HISTORY RECORD

FAA Control # <u>02-01-240</u>

Subject: ICAO Holding Pattern Safety Issue

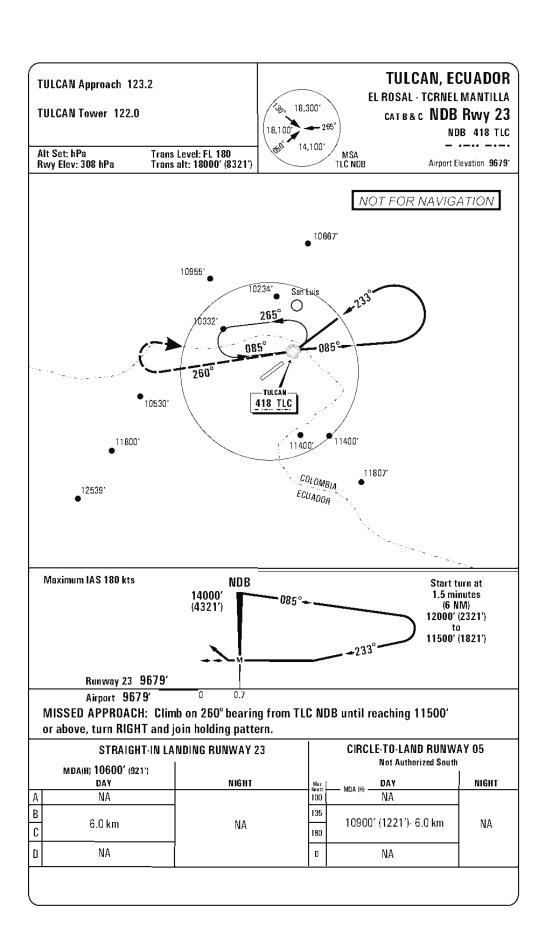
On the attached pages are a generic graphical representation of the Tulcan NDB IAP as it appeared on the date of the accident, as well as graphics of the topography for the area with placement of TERPS 230 and 175-knot holding templates for 14,000 feet. Note that the only reference to a speed limit is in the profile view of the approach chart, which most pilots would associate with the base leg outbound as shown in the profile view. Note also there is no minimum holding altitude shown in the plan view.

Recommendation: That this forum initiate the necessary actions to cause the United States representatives to ICAO to modify PANS-OPS holding pattern criteria and associated procedural text to: 1. Deny construction of holding patterns for jet airplanes with speeds less than standard, for altitudes above 10,000 feet. For altitudes 10,000 feet, and below, and where an operational requirement exists, deny a speed reduction for jet airplanes of less than 200 knots. Where a unique requirement exists for lower speeds, such IAPs should not be issued to the public; rather they should be similar to our "specials" and issued only to carriers with a demonstrated need and proven qualifications. 2. That PANS-OPS be clarified to require any non-standard holding speed limit to be associated directly with the holding pattern's plan view icon (and in the profile view as well where an affected holding pattern is charted in the profile view. 3. That PANS-OPS be clarified to require the charting of the minimum holding altitude in a clear and unmistakable manner adjacent to the holding pattern icon.

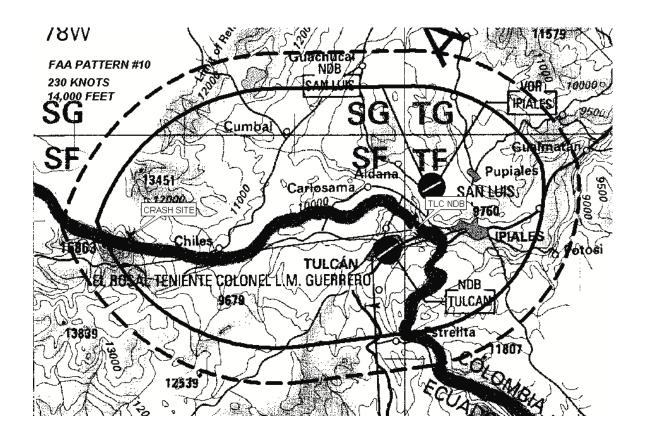
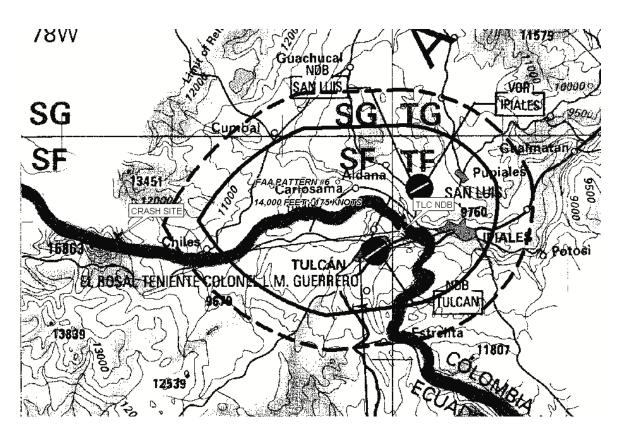
Apparently, the designer of the Tulcan NDB IAP elected to constrain the holding pattern to 180 knots, with a minimum holding altitude of 14,000 feet. In the United States, such a pattern would have to be the standard 230-knot pattern to be authorized for jet airplanes. These United States criteria are based on valid aerodynamic premises. It appears that PANS-OPS terminal instrument criteria are open to more conjecture, at least as to holding pattern design, than are U.S. TERPs. It is apparent, though, that the standard application of PANS-OPS criteria would have dictated a 240-knot pattern at Tulcan above 14,000 feet, and a 230-knot pattern at 14,000 feet.
